## **Leadburn Junction**

### **Initial Comments –**

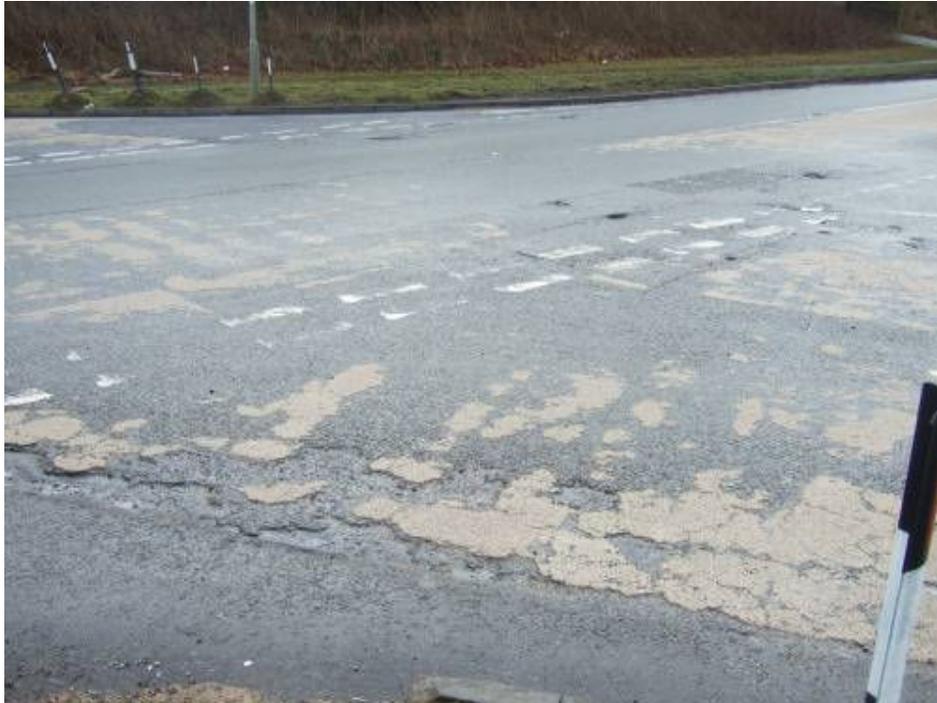
The High Friction Surfacing HFS is badly worn in places. Some of the surfacing not treated with HFS is polished in places: re-texturing / surface-dressing would help.

6. Repair High Friction Surfacing.  
Follow-up – Commercial Services have added this location to the list of sites requiring new/refurbished HFS but cannot give timescale for work.

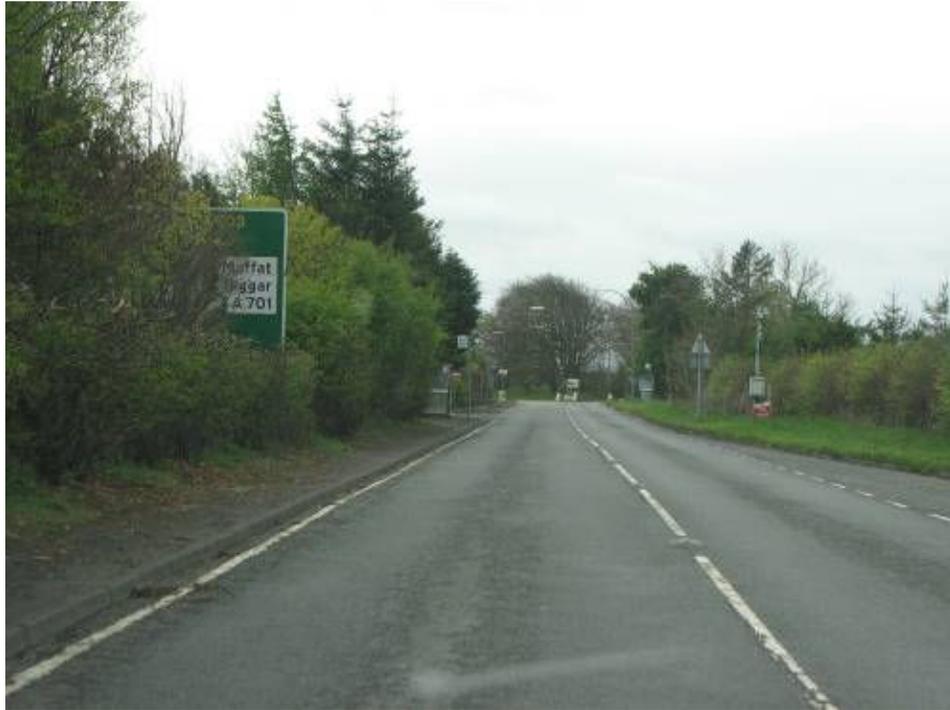
Some of the existing signs are in poor condition/hidden by overgrowth.

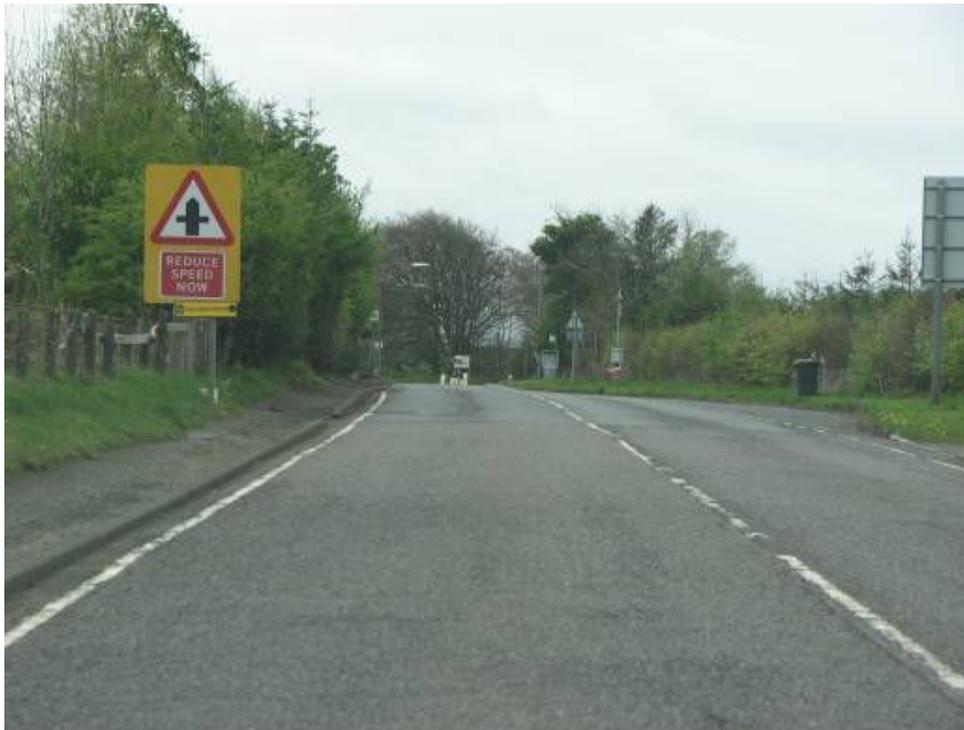
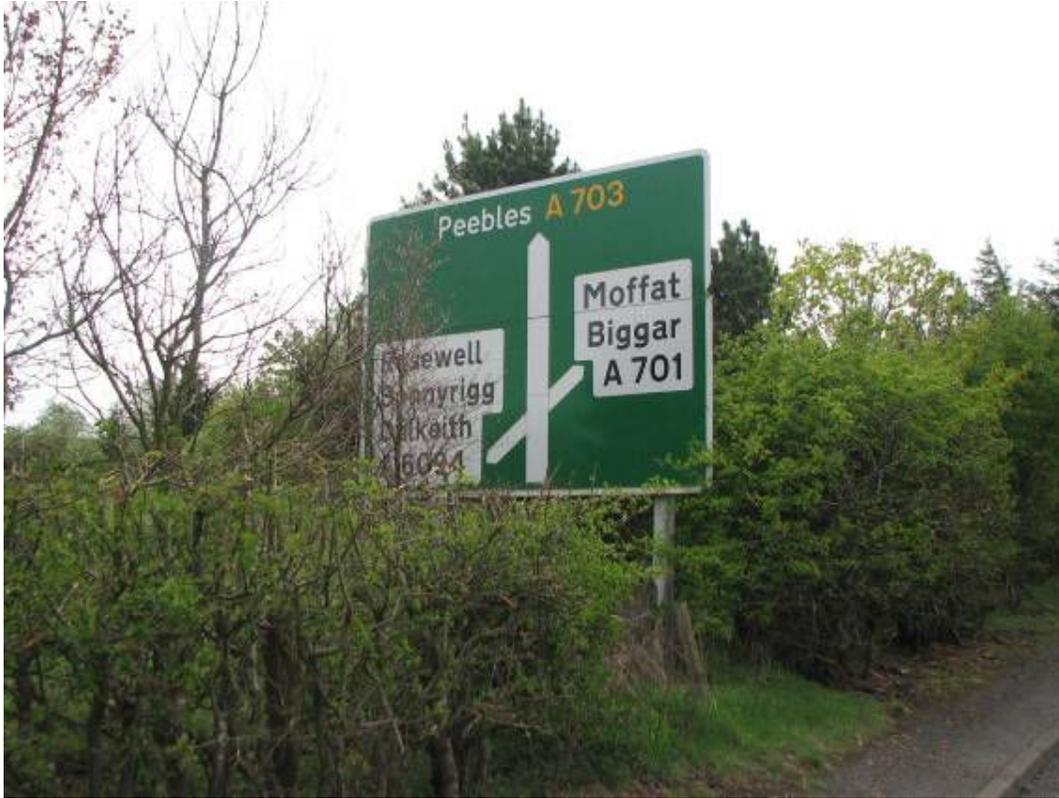
Although there is a warning sign for the crossroads drivers won't be able to see the hidden Advance Direction Sign (ADS)

1. Speak to Commercial Services Division regarding clearing of undergrowth hiding Advance Direction Sign. –  
Follow-up – Commercial Services have added this to their work programme.

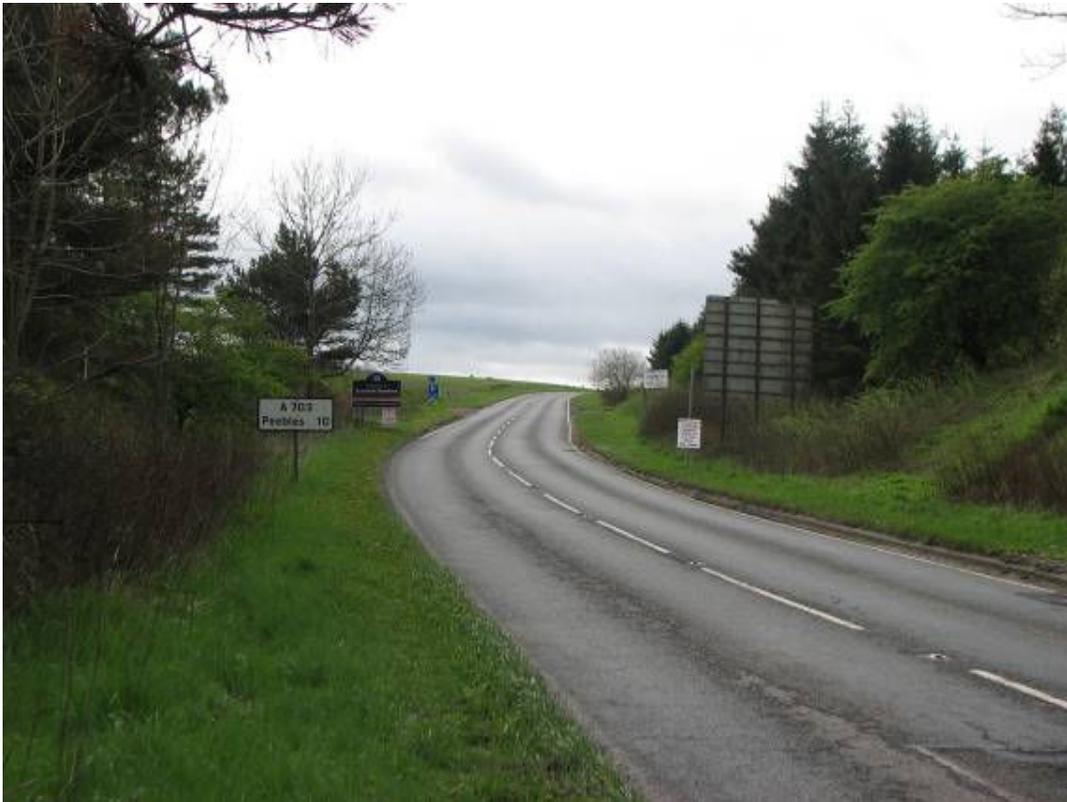
Various unnecessary/illegal signs nearby might not be causing problems but are not likely to help the situation.

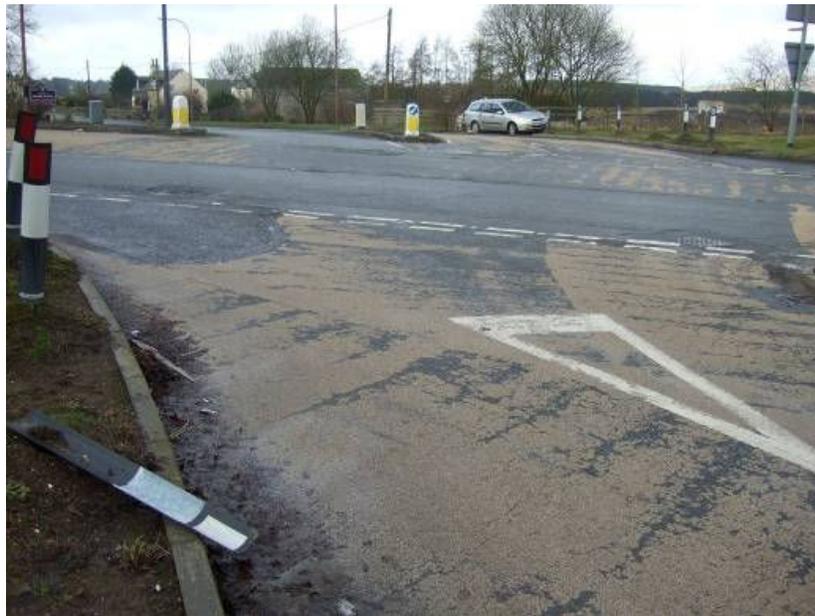
The A6094 approach is wide enough for 2 cars to sit side by side trying to enter the A703 and A701 and/or for traffic for the A703 to think they can go round bend fast – to reduce risk of A701 > A703 vehicles running into their back.

7. Consider “Imprint” or “Textureflex” on over run-areas on nearside of A6094 up to Give Way to square off approach even more and narrow to single-file (with single-file traffic sign? Consider whether this could be temporary?).

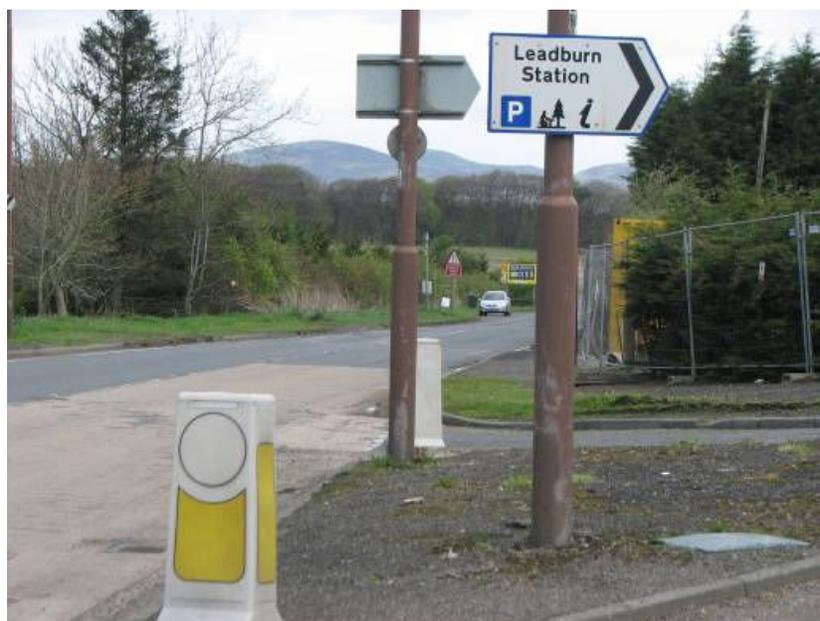
Some A6094 > A703 drivers were observed going too early i.e. before they approach the give-way line, when they do not have full vision to their right. Screening at driver's eye height on the splitter island behind the bollard might persuade them to wait until they could see.

Lighting columns etc on the islands could easily hide a car, and certainly a motor-cycle (but this doesn't seem to have been involved in any of the recent reported injury crashes), when close to the give-way lines. The Council's Street Lighting Section to be requested to review the current locations to establish if the columns could be re-positioned.

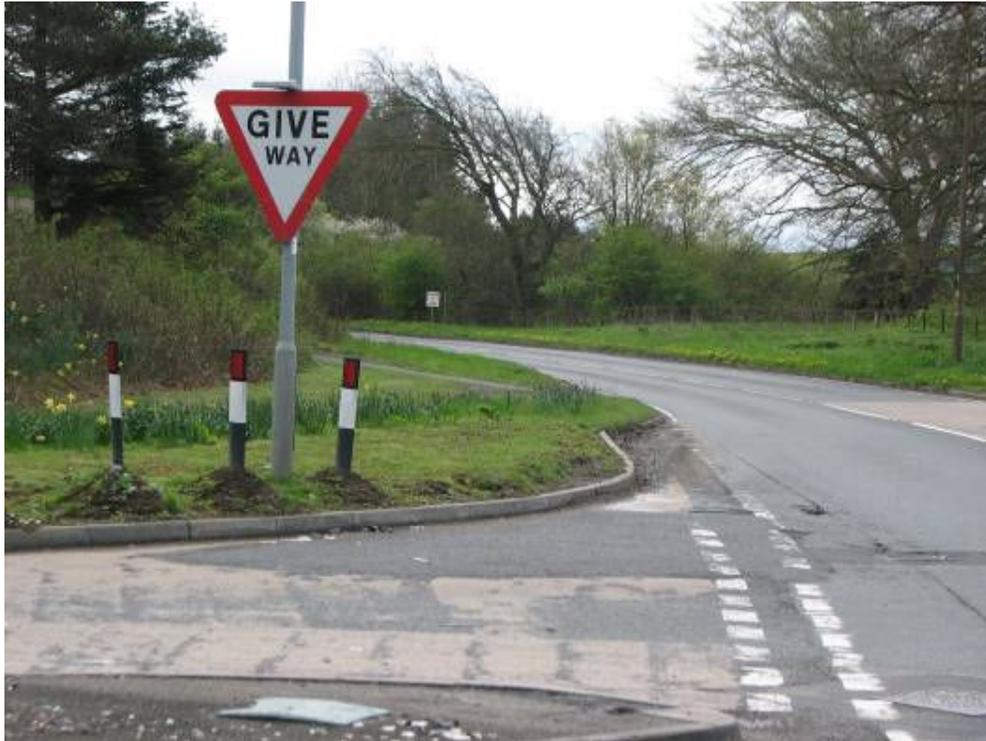
Traffic going straight over or turning right from the A6094 might have to be this close to the give-way lines to see well enough to the A703 to the left; suggesting the benefits which could arise from a review of the existing visibility splay. However, the original solution was expensive due to the lack of land available and the difficulty in obtaining the land required to improve the visibility splay.

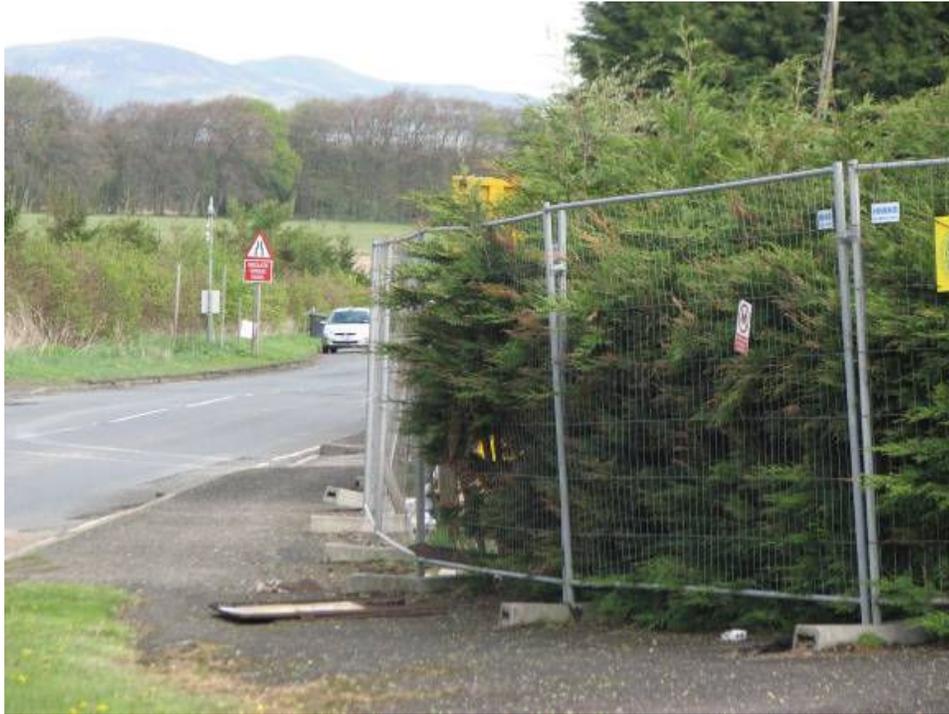
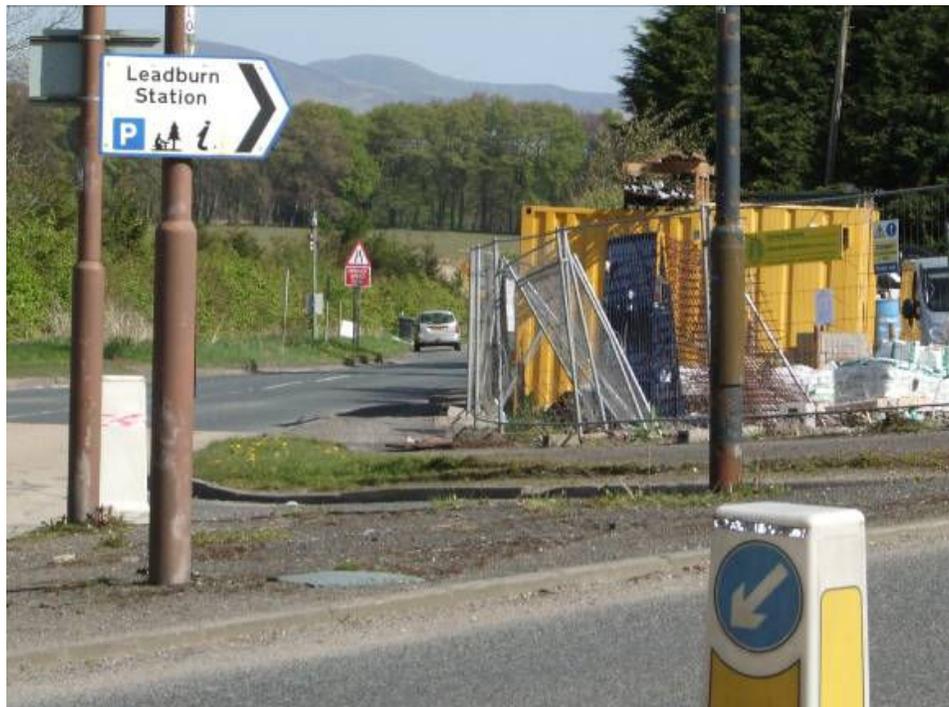
The hedge in the photo below has now been removed and visibility should be even better once the temporary fence and site storage container are removed

However, better visibility for drivers looking right when further back from the give-way line may lead to more nose-to-tail shunts if the car in front doesn't move off as expected.
