## **Leadburn Junction**

### **Initial Comments –**

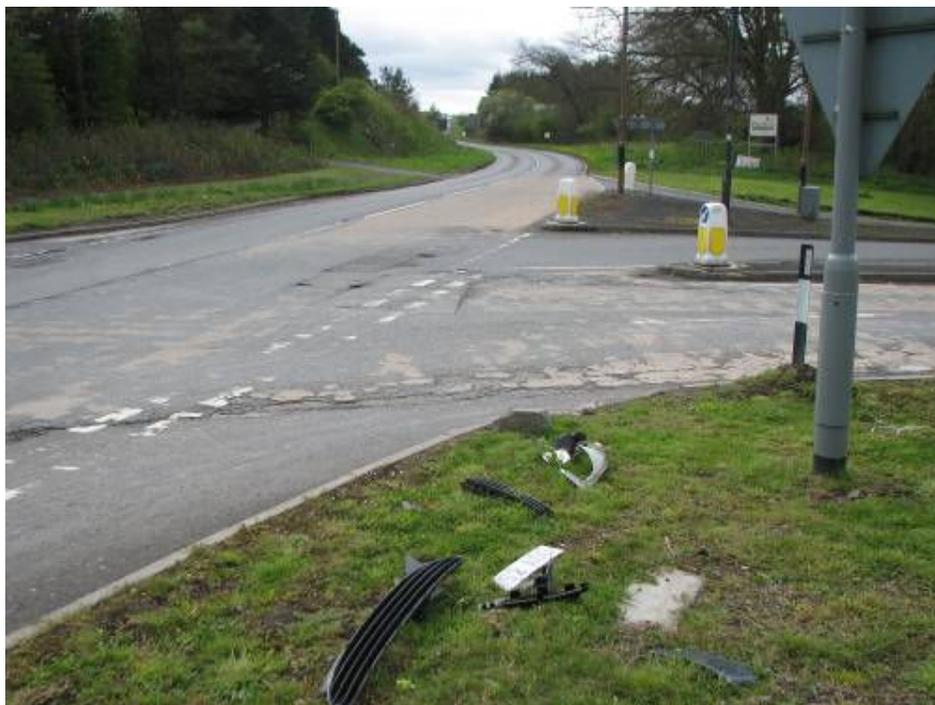
3 reported injury crashes at junction in last 3 years (up to end of April 09) – there were more than that about half a mile or more away but they were nothing to do with junction. One (human) injury crash in 2006-8 south of the junction, but still in Midlothian, happened after one car stopped for a deer and was hit from behind. (all photos below from 2009)

The injury accidents at the junction are less than before the changes in 2006, so the junction does not appear near the top of the Council's priority list for major improvements [Note: at the time of the meeting with the Community Council the junction was rated 44<sup>th</sup> on the priority list]. There are several other sites in the near vicinity on both the A6094 and the A701 with more reported injury accidents.

As well as the injury accidents there is evidence of some damage-only accidents so there is still some cause for concern. Unfortunately there are no accurate records of damage only accidents so no definitive figures are available.
